FITTING INSTRUCTIONS

TAIL GATE LIFT ASSIST KIT TO SUIT HILUX SR5 'A' DECK 4714030

KIT: 6177683

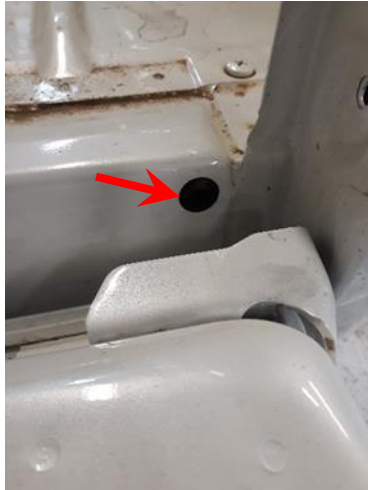
1.1 Open the tailgate. Remove and discard the rubber bung (if fitted) on the body of the tub near the RH Hinge.

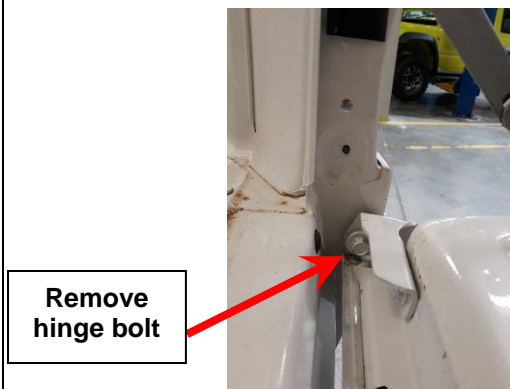
1.3 Remove the hinge bolt from the RHS of the tailgate and discard.

Clean the threaded hole with WD40 or similar.

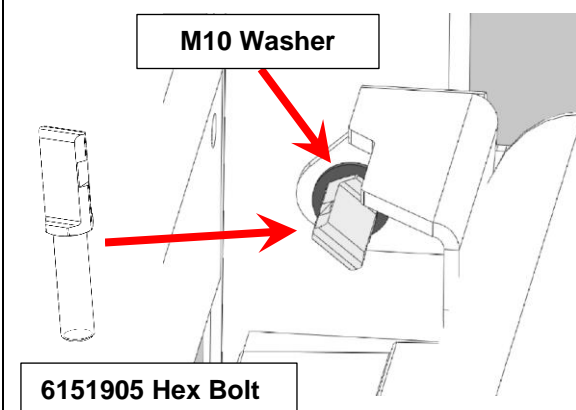
1.4 Replace the hinge bolt with the 6151905 Hex Bolt and M10 Washer. Tighten the Bolt whilst allowing the tailgate to rotate easily by hand and orient it as shown. If necessary, slightly loosen the Bolt by turning it anticlockwise to achieve this position.

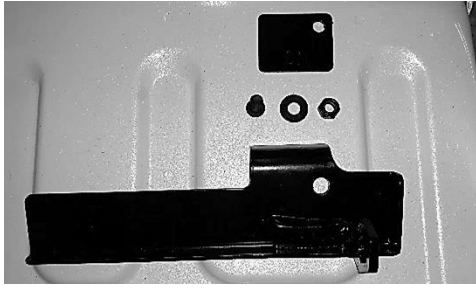
- 1.5 Place the 4654527 Bracket onto the tub so the rear of the bracket butts up against the tub while the return fold with large radius is against the tub floor. Slide the bracket so the hexagonal hole of the Bracket slides over the Hex Bolt in the orientation as shown.
- 1.6 Slide the bracket along so the hole in the tub aligns with the hole in the bracket.

It is important to maintain the orientation of the bolt.

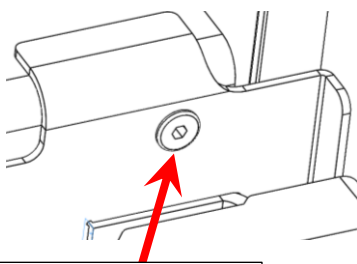
Assembly as viewed from underside of Tub

- 1.7 Affix the Bracket to the tub using the 6151882 M8 Ultra Thin Head Screw through the aligned holes from the tailgate side. From the underside of the tub, use the 3195116 Back Plate, M8 Washer and Nyloc as shown.

Do not fully tighten the screw & nut at this stage.

1.19 Tail gate in lowered position: Tighten the 6151882 M8 Ultra Thin Head Screw & M8 Nyloc nut which was left loose on step 1.7. Torque to 10Nm.

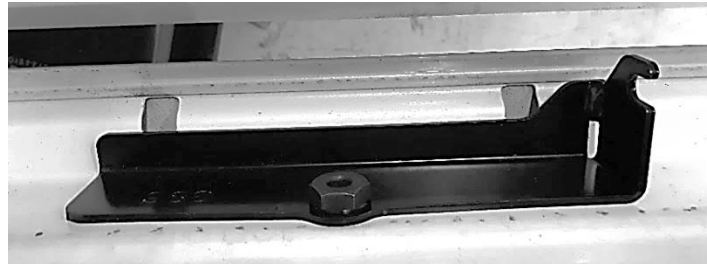
Locate the centre hole on the tailgate

Back Plate and Nut as viewed from inside the tailgate

- 1.9 Locate the lower centre hole of the tailgate. From the outside, insert the 6365071 Threaded Bush through 3750386 Bracket and the tailgate hole and position the Bracket.
- 1.10 From inside the tailgate, (through the inspection panel opening), locate the previously inserted threaded bush and align the 3195138 Back Plate and M12 Nyloc nut into position and **tighten to 10Nm**

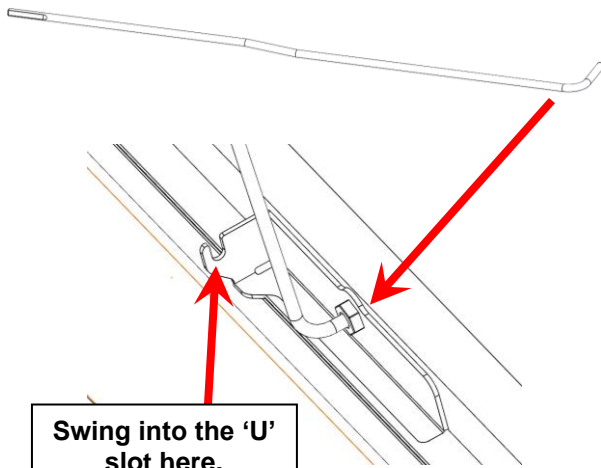
Swing into the 'U' slot here.

- 1.11 Taking the bent end of the Torsion Spring, feed it into the Threaded Bush and swing it into the 'U' slot of the Bracket.

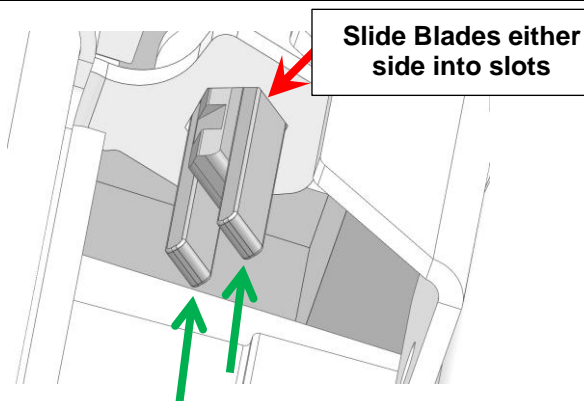
Slide Blades either side into slots

- 1.12 Slide in the 3193801 support blades through the hex bracket above the large flat surfaces of the Hex Bolt. (Blades should hold in position)

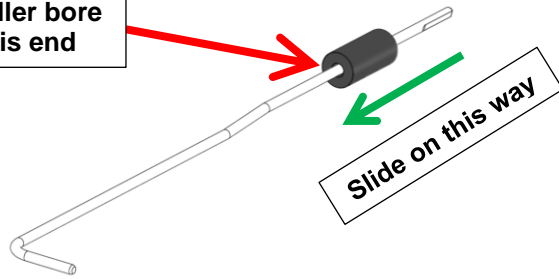
Smaller bore
This end

- 1.13 At the free end of the Torsion Spring, place the sleeve over the Spring. (Insert the sleeve through the smaller bore into the Torsion Spring.)

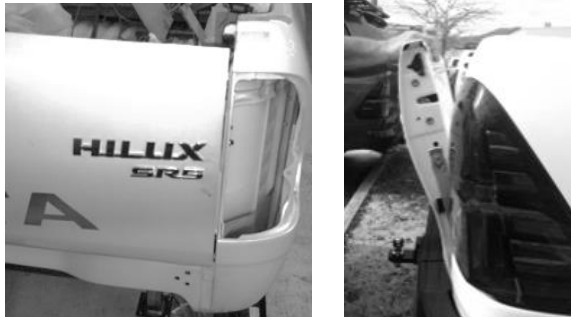
Tailgate opened
approx. 30°

- 1.14 Swing the tailgate to approximately 30° from the closed position and support (Ajar position)

- 1.15 Hold the Blades in position and from below the tailgate, slide the flat section of the torsion spring in between blades. (you may need to adjust the tailgate position to ensure clean alignment.)

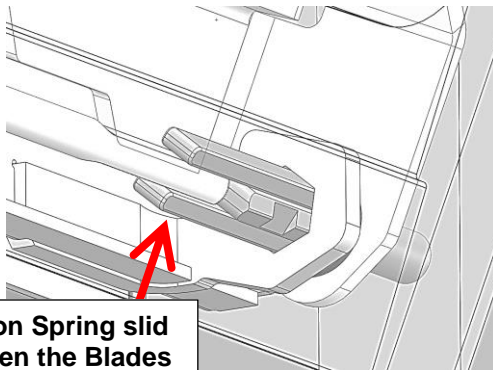
Torsion Spring slid
between the Blades

- 1.16 Once the torsion spring is in position (and the tailgate remaining ajar) slide the Sleeve over the Blades and Hex Stud, the Sleeve should go very close to the Hex Bracket.

Note: If there is misalignment, the Sleeve bush will not slide in fully, and there will be a big gap between bracket and the Sleeve Bush.

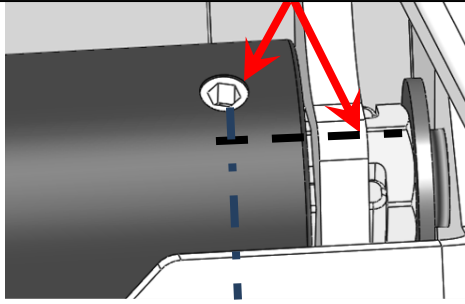
Grub Screw aligned to Hex Stud and Below surface of Sleeve

Grub Screw top surface **MUST** be below bush surface.

1.18 Align the Grub Screw hole to the upper ridge on the Hex Stud and screw the Grub Screw down to **6Nm** onto the machined flat slot of the Hex Stud. Check that the Grub Screw top surface is below the Sleeve outer surface when tightened. If it is not, slightly rotate bush and re-tighten so the Grub Screw's top surface is below the Sleeve surface. Ensure the Sleeve is secured by trying to move or rotate it. When the Grub Screw is properly positioned and tightened fully to 6Nm the Sleeve will not move in any direction.

If the Grub Screw is not tightened correctly into the groove, the Sleeve may become loose and allow it to slide off the Hex Stud and dislodge the Torsion Spring. Damage or injury may result if not correctly tightened.

If the top of the Grub Screw sits above the surface of the Sleeve, it indicates the Grub Screw is not positioned correctly. Loosen the screw slightly and with the tailgate held ajar, rotate the Sleeve slightly so the Grub Screw and Hexagonal ridge are aligned. Repeat tightening procedure.

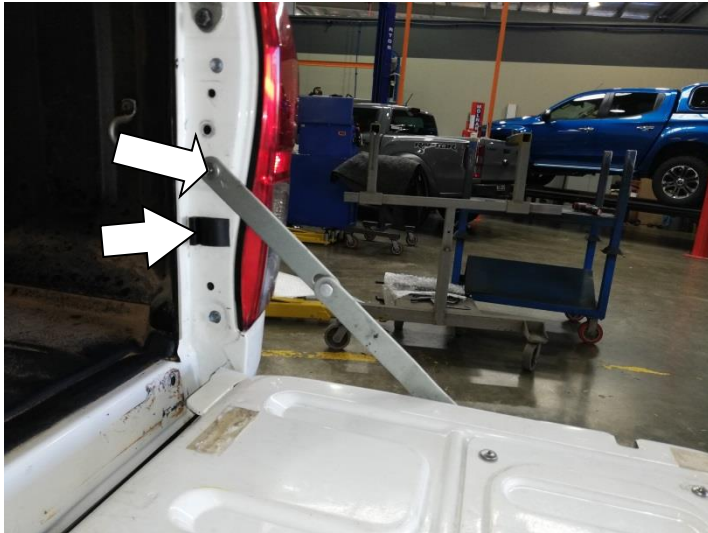
- 2.1 Undo the 2 screws (1 screw on the body & 1 on the tailgate) holding the limiting strap on RH side.
- 2.2 Remove the straps, washer & strap guide bracket (on the tailgate) and discard all items.
- 2.3 Clean the holes with WD40 or similar.
- 2.4 Remove plastic buffers on the body and on the tailgate and discard.

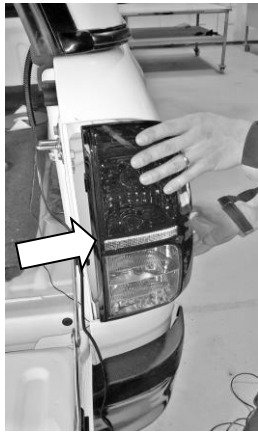
- 2.5 Undo the 2 screws holding the rear tail lamp assembly to the rear of the tub on the right-hand side.
- 2.6 Pull the light outwards to the side of the vehicle and disengage it from the tub.
- 2.7 Remove the Original Strap and all strap hardware whilst retaining only the original M8 Bolts

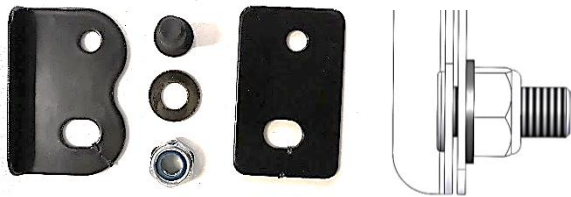
- 2.1 Locate the 3750441R Upper Mount Bracket and fasten with 6152031 M10 Ultra Thin Head Screw, Washer and Nyloc as shown. Torque M10 Ultra thin head screw to **12Nm**.
- 2.2 Using the remaining hole in the Upper Mount Bracket as a guide, drill through it an 8mm diameter hole and de-burr the hole in the side panel of the tub. Paint the drilled hole with suitable primer paint to prevent rust.

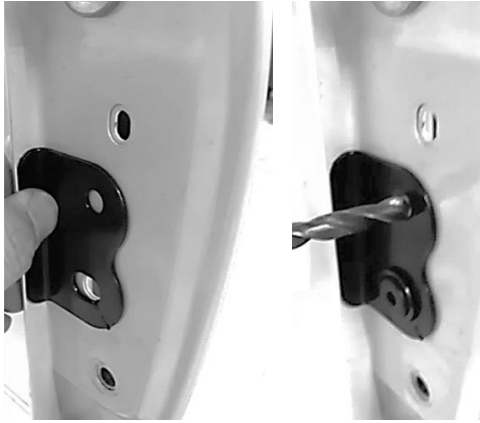
2.8 Remove the Bracket and reassemble using the 3195150 Plate on the inside of the Tail Light cavity to sandwich the panel.

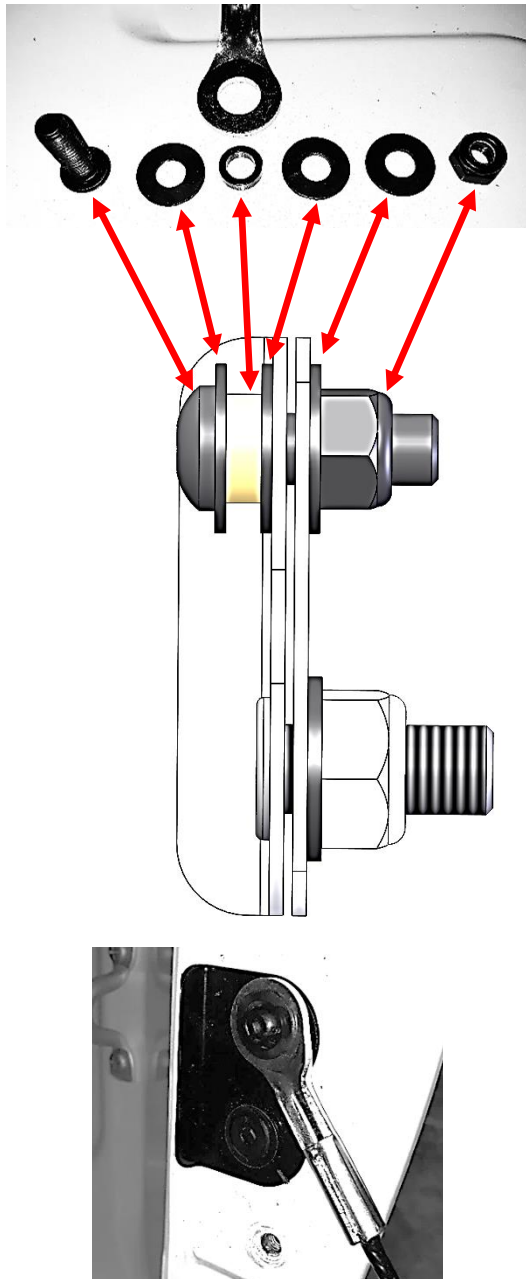
2.3 Fasten the eye end of the 6821348 Cable through this hole as shown using an 6151464 M8 Button Head Screw, 3x M8 Washers, 5848468 Spacer and Nyloc Nut.

Tighten M8 button head screw to 22Nm
Torque M10 Ultra thin head screw to 12Nm.

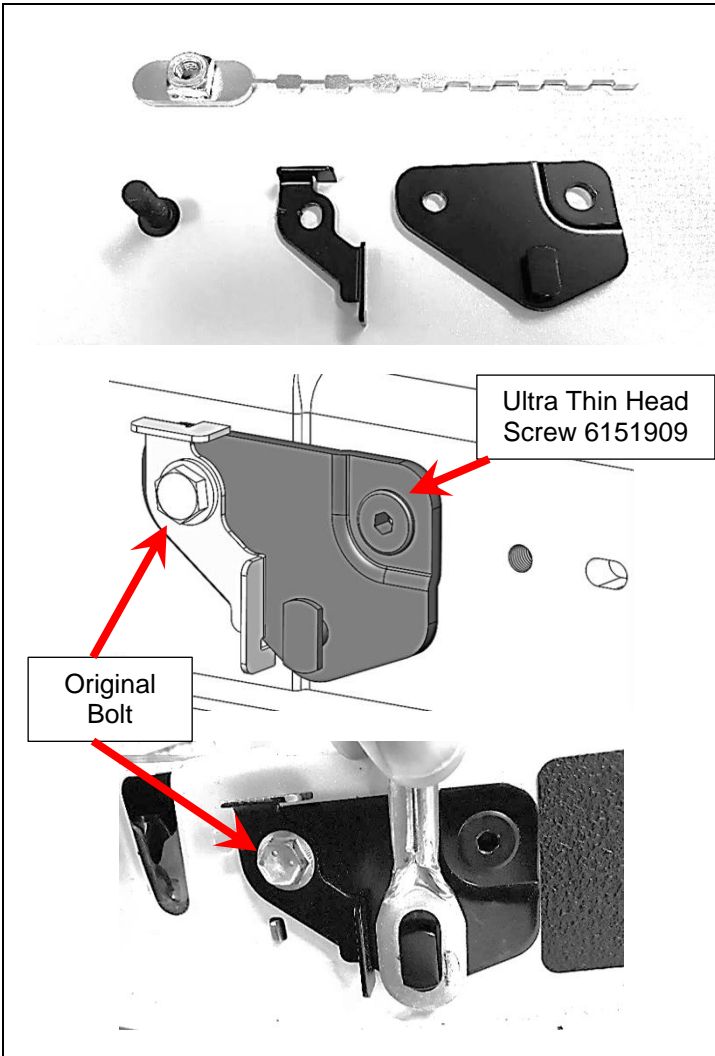
- 2.4 Using an 6151909 M8 Ultra Thin Head Screw, affix the 3750443R Lower Cable Mount and 3750444R Cable Keeper to the tailgate as shown, so the remaining hole is aligned to its mating hole in the tailgate. Using the 3759081 Nut Plate on the inside of the tailgate, tighten the 6151909 M8 Ultra Thin Head Screw to **10Nm**.
- 2.5 Using the original M8 Bolt previously removed, locate the 3750444R onto the Lower Cable Mount and Tighten to **22Nm**.
- 2.6 The slotted end of the cable may now be attached.

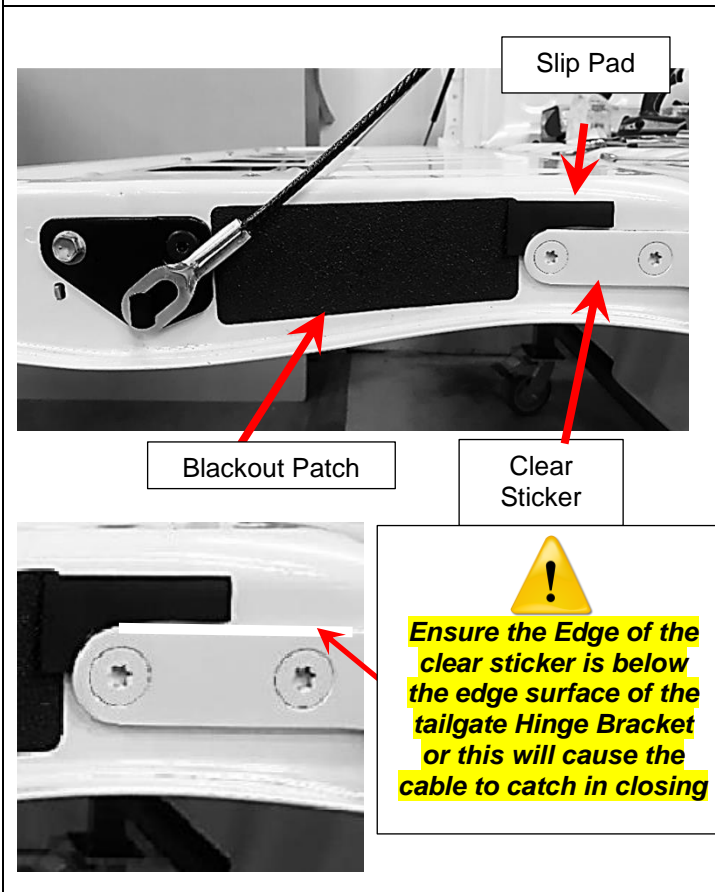
- 2.7 Using an alcohol wipe, clean all areas along the side of tailgate where the 2125739R Blackout Patch, 2125755R Slip Pad and 2125725 Clear Sticker are to be used. Clean for both sides of the tailgate
 - 2.8 Attach the Slip Pad first and then the blackout Sticker in position as shown, making sure to cover all holes and keep even to the line of tailgate
- These items are necessary to protect surfaces and allow the cable to ride over the tailgate hinge without damaging the cable or mating parts.**

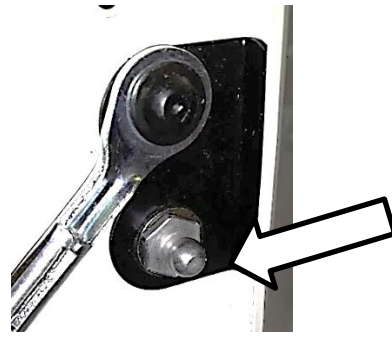
- 3.1 Fitting the LH Cable Retaining Strap is a repeat of the instruction for RH in Section 2

The only difference to RH is using the 6152030 Ball Stud in place of the 6152031 Ultra Thin Head Screw as shown.

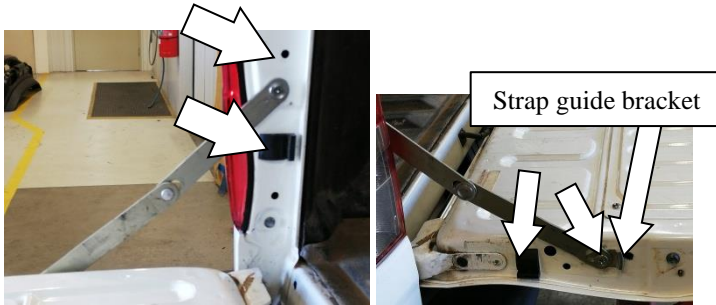
Section 4: FITTING DAMPENING STRUT ON LH SIDE

- 4.1 Ensure RH side strap is holding the tailgate and similar to RH side follow steps, 2.1 to 2.4 to remove the OEM straps on LH side.

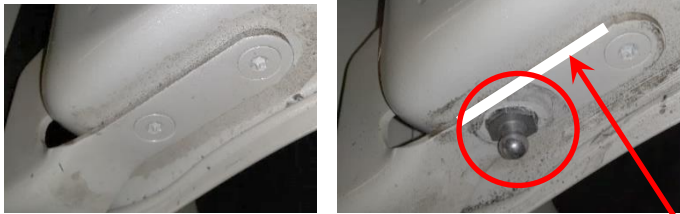
- 4.2 On the tailgate, remove the countersunk hinge screw nearest where the tailgate mounts to the vehicle and replace with the 6151908 Countersunk Ball Stud.

Tighten the Ball Stud **to 22Nm**

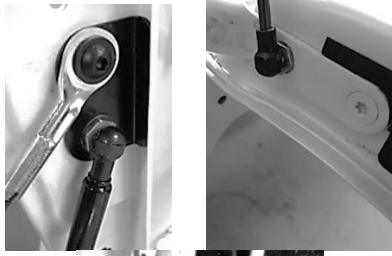
- 4.4 Fit the 4590031 Damper with the Rod end of the Damper clipped to the ball stud fitted to the tailgate.
- 4.5 Fit the cylinder end of the Damper into the to the ball stud on the LH side of the vehicle tub.
- 4.6 Operate the tailgate 5 times to make sure the action is opening and closing easily.

Check the cable strap is sitting under the lower end of the Damper and to the tailgate side when the tailgate is closed
